Manhole Inspection Summary

Manhole # S25A__046MH

Insp Date: **11/28/07 11:37 AM**

Location Address: **1003 EDMONDSON-BENNETT** Cross Street: **SHROEDER ST**

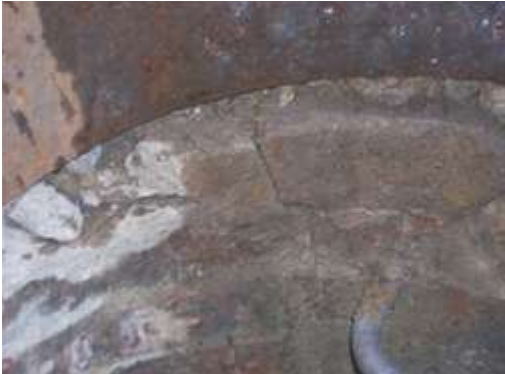
Defect 2

Chimney / Frame Adjustment ☒ Exists Material: **Brick** ☐ Parged Height: **3** (in.)
Condition: ☐ Sound ☐ Cracked ☐ Root Intrusion ☐ Loose Brick ☒ **Deteriorated**
Infiltration: ☒ None ☐ Joint ☐ Cracks ☐ Mortar ☐ Roots ☐ Wall

Corbel Material: **Brick** ☐ Parged Type: **Concentric/Eccentric**
Condition: ☐ Sound ☒ **Cracked** ☐ Root Intrusion ☐ Loose Brick ☐ Deteriorated
Infiltration: ☒ None ☐ Joint ☐ Cracks ☐ Mortar ☐ Roots ☐ Wall

CRACKED CORBEL AND
DETERIORATION OF CHIMNEY

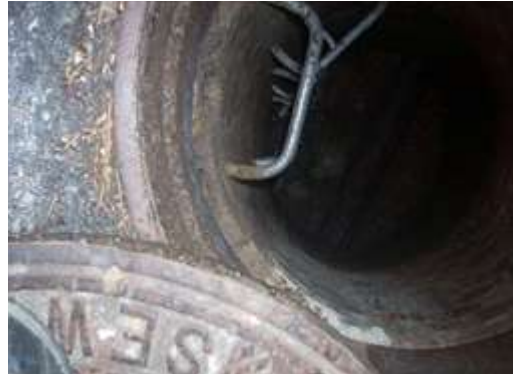
Defect 1

Frame Offset: **2** (in.) Condition: ☒ Sound ☐ Cracked ☐ Leaks

FRAME OFFSET

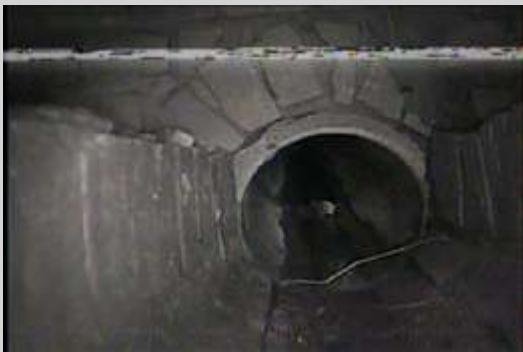
12 O'Clock Outflow

8 in. Circular Gravity Sewer
Pipe Out @ 12 O'Clock

Pipe Height: **8.4** (in.) Rod and Bar (Angled)
Pipe Material: **Clay** ☐ Pipe Lined
Invert Depth: **10.81** (ft.) Flow Characteristics: **Slow**
Deposits: ☒ None ☐ Mud ☐ Sludge ☐ Debris ☐ Grease
Silt Depth: (in.) Deposits Extent:
Infiltration: **None** Pipe Seal Cond: **Sound**

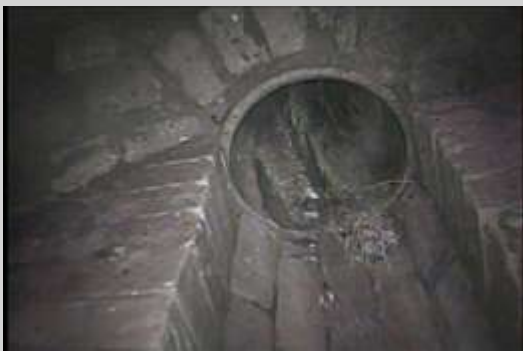
6 O'Clock Inflow

8 in. Circular Gravity Sewer
Pipe In @ 6 O'Clock

Pipe Height: **8.4** (in.) Rod and Bar (Angled)
Pipe Material: **Clay** ☐ Pipe Lined
Invert Depth: **10.77** (ft.) Flow Characteristics: **Slow**
Deposits: ☒ None ☐ Mud ☐ Sludge ☐ Debris ☐ Grease
Silt Depth: (in.) Deposits Extent:
Infiltration: **None** Pipe Seal Cond: **Roots**
